Event Report

# Chi-Chi, Taiwan Earthquake

September 21, 1999 1:47 a.m. M7.6 23.8N 120.8E 7 km depth

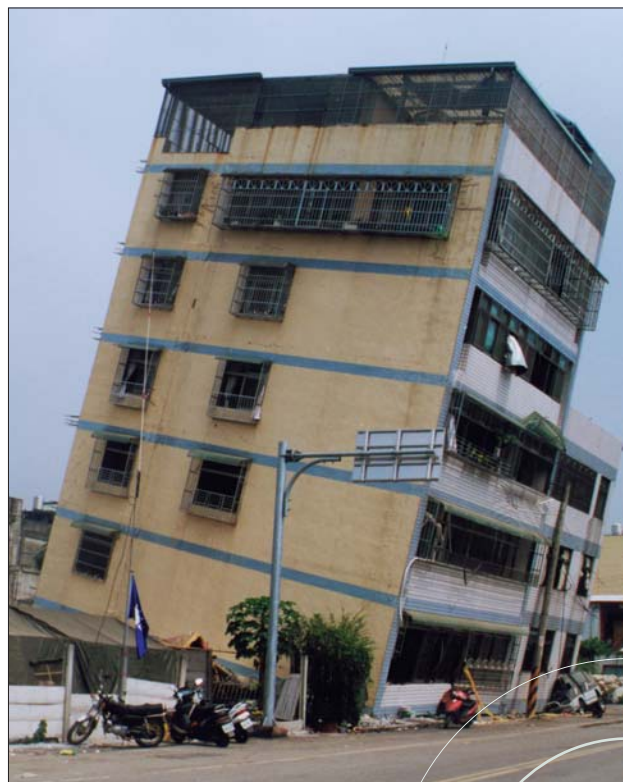
*A partially collapsed reinforced concrete building in Dungshr. Approximately 15,000 buildings were heavily damaged or destroyed, the majority of which were mid-rise reinforced concrete structures.*

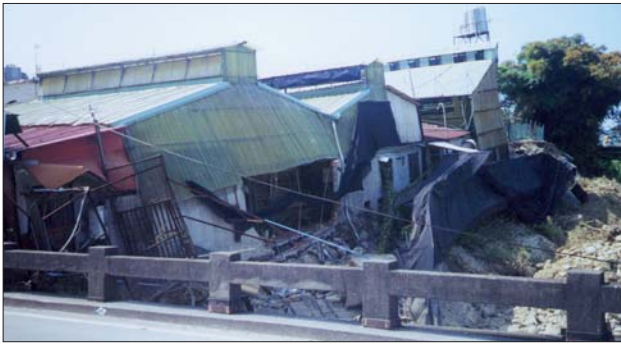
*Ground deformation associated with the earthquake faulting destroyed these lightweight structures and formed a dam across the riverbed near Fengyuan.*

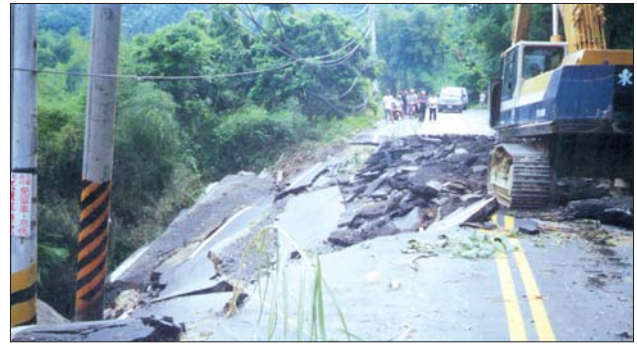
*Landslides caused most of the more than 600 road disruptions, limiting access to remote mountain villages for more than a week and hampering emergency operations throughout the epicentral region.*

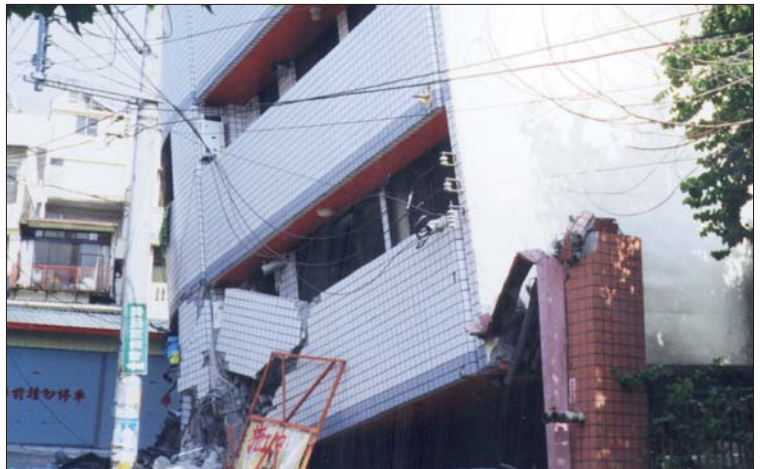
*The non-ductile concrete frames in many buildings' first floors collapsed when they were unable to withstand the lateral earthquake forces.*

Damage to low and mid-rise buildings (less than 8 stories high) was quite extensive and caused a majority of the earthquake's fatalities. Most collapsed buildings were reinforced concrete frame buildings with brick infill walls, typically accommodating commercial uses on the first floor with residences above. Most damage was caused by poor, non-ductile concrete detailing and soft story conditions.

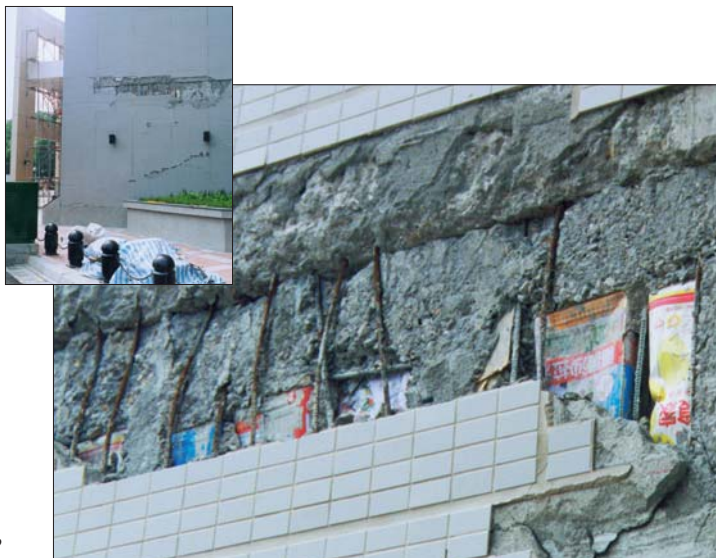
*Spalling on the exterior veneer exposed salad oil cans in the concrete beams of this newly constructed reinforced concrete building in Nantou City.*

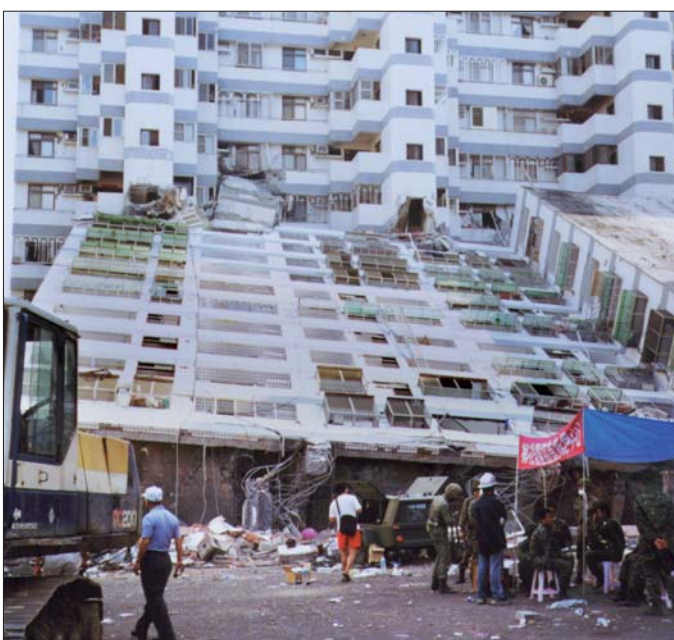
included two as far away as Taipei. As with the shorter buildings, most damage was caused by the catastrophic non-ductile failure of first-story columns. Soft story conditions (from open areas in the first story) also contributed to the damage, particularly concentrating damage in the first-story columns.

Deficiencies in steel reinforcement details included: (1) a lack of adequate column confining steel, (2) a lack of 135-degree hooks on the confining steel, and (3) slicing of all vertical steel reinforcement at the same location in the column, directly above floor levels.

*The combined vertical weight of the building and earthquake overturning forces exceeded the load-bearing capacity of the columns, completely toppling some buildings, such as this one in Dali.*

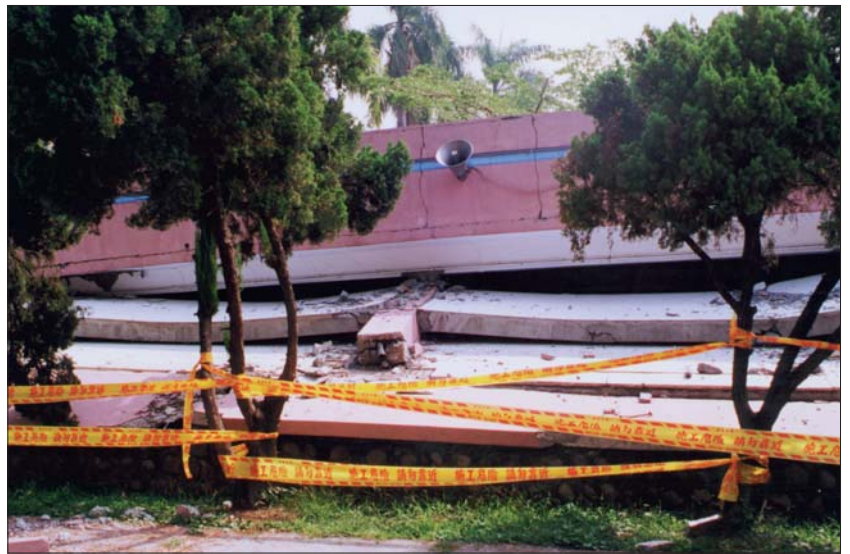
*A pancaked classroom building on a junior high school campus in Wufeng.*

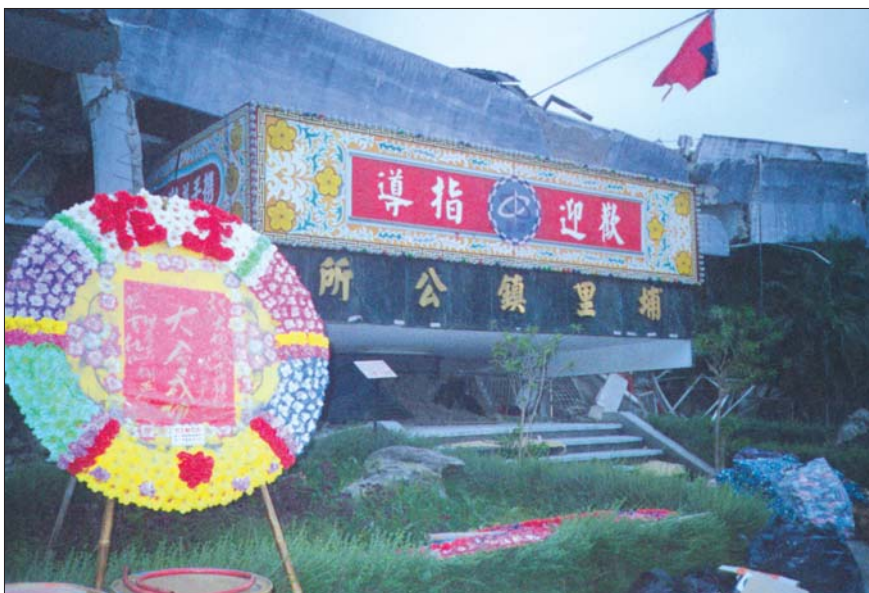
*The 4-story reinforced concrete city administration building in Puli also suffered a pancake collapse.*

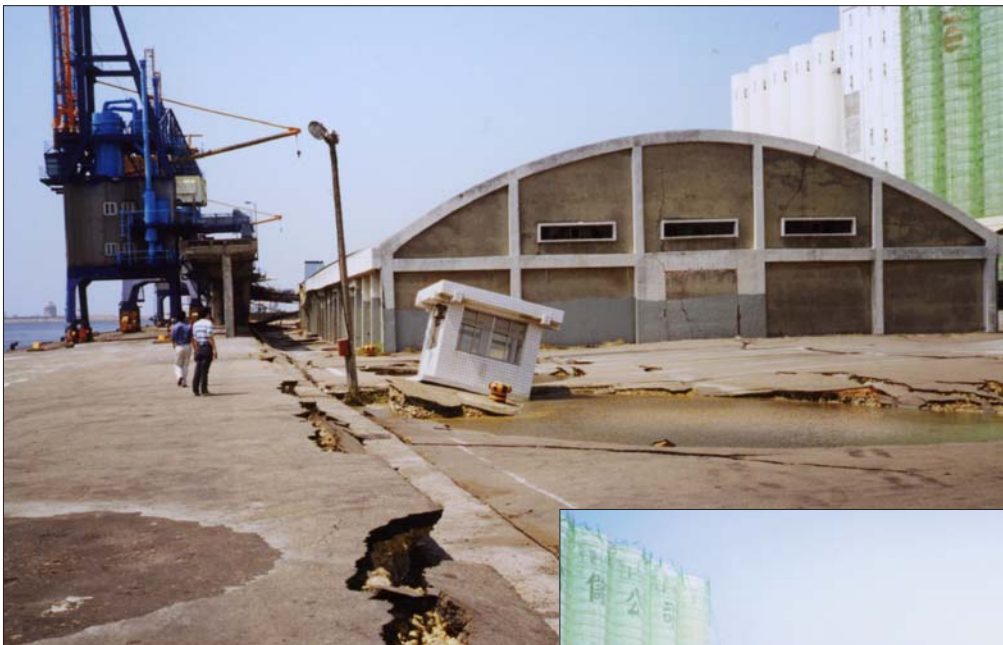
The port of Taichung is one of four ports that handle international trade in Taiwan, and is second in size to Taiwan's port of Kaohsiung in the south. As much as 4 feet (1.2 meters) of ground settlement was observed, and liquefaction and ground subsidence seriously damaged four of the port's 45 berths. All crane facilities at the affected berths appeared undamaged, but were slightly tilted along with the supporting structures. Earthquake-induced sloshing seriously

*As much as four feet of ground settlement was observed along the entire length of a wharf (approximately 1,000 meters, or 3,300 feet) at the port of Taichung.*

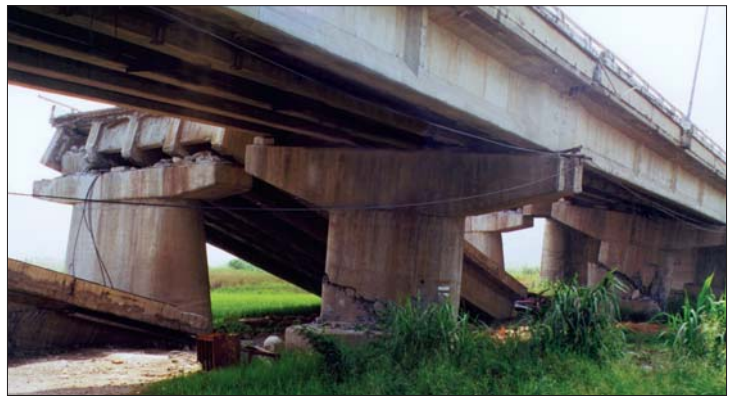
Most of the collapsed bridges were located on the provincial highway Tai-3, which runs north-south through Taichung and Nantou counties, and coincides with an extensive part of the Chelungpu Fault rupture. Most were constructed before more stringent seismic requirements were implemented. Bridges constructed over the fault were severely damaged by the rupture, even those built recently. The fault rupture tended to push the road bed up, unseating it from the spans. Several bridges near the fault collapsed when the embankment behind the bridge abutment moved significantly.

*On Tai-3 near Wufeng, the Chelungpu Fault rupture sheared through a bridge column, causing several spans to collapse.*

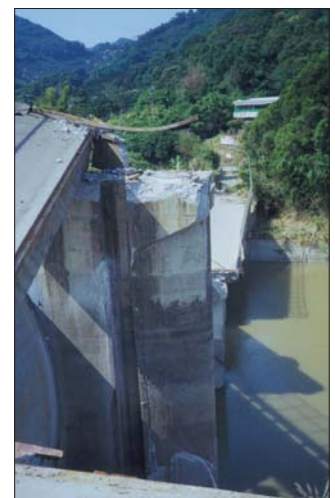
The 921 earthquake disrupted service to more than 80% of the region's 5 million water customers, and a full recovery will take several months. The Shih-kang Dam, which supplies 40% to 50% of the water consumed in the Taichung area, is nearly 25 years old, and was apparently built without knowledge of the faults. The dam failed when vertical fault displacements on both sides of the dam caused large relative ground motions between individual piers. Faulting and associated ground deformation raised one portion of the dam by nearly 10 meters (30 feet), causing three of the 18 concrete piers

*Vertical ground displacements due to earthquake faulting caused three piers to collapse on the northern end of the Shih-kang Dam.*

and spillways to collapse. The resulting reservoir discharge did not inundate downstream uses, but the water supply was interrupted for some time.

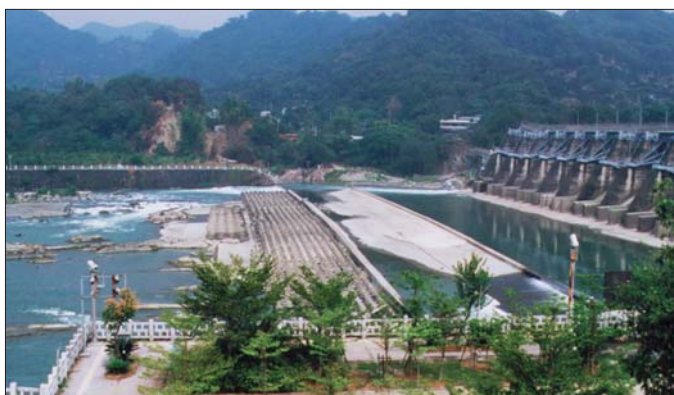
*Vertical ground displacements associated with earthquake faulting have raised the overall ground elevation around the Shih-kang Dam, exposing areas that were once covered by water.*

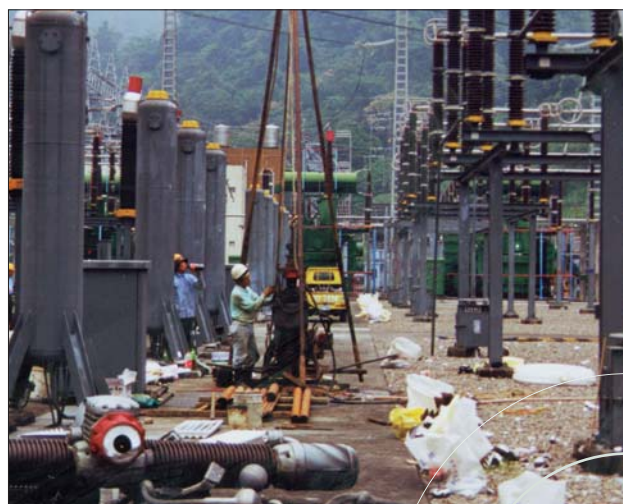
Additional power generation and transmission facilities throughout the epicentral region sustained considerable damage, and all hydrogenerating capacity in the island's system was lost for more than 10 days. The switchyard at the Tienlun hydroelectric plant was almost completely destroyed, and the generator, water pipelines, and penstocks suffered some damage. The dam at the Sun Moon Lake reservoir in Nantou County also sustained damages. Without the hydropower for regulating frequencies across the island-wide power grid, the electrical system was unstable for some time.

*Clean-up underway at the Tienlun switchyard, nearly one month after the earthquake. Similar heavy damage that occurred at the Chungliiao substation was already cleaned up by this time.*

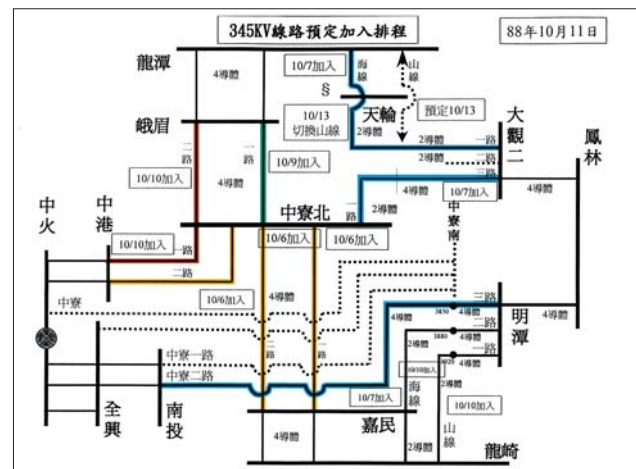
- The Chungliiao substation, a major hub in the island's high voltage transmission network that directs 45% of the north's power demand, sustained heavy ground shaking of 1.0 g, which completely destroyed equipment in the southern switchyard and activated a very large landslide that damaged over half of the site and snapped an incoming transmission line
- Two nuclear power plants located in the northern part of the island, though sustaining no significant damage and experiencing ground shaking at only 0.3 g, tripped due to overall system imbalance and were shut down for nearly a week after the event

As part of the restoration plan, the undamaged equipment at the Chungliiao substation was carefully mapped and temporary routings were designed to get power through the station again and headed north. The pink, yellow, and blue shading illustrate restored transmission routes through the central region and to the north.

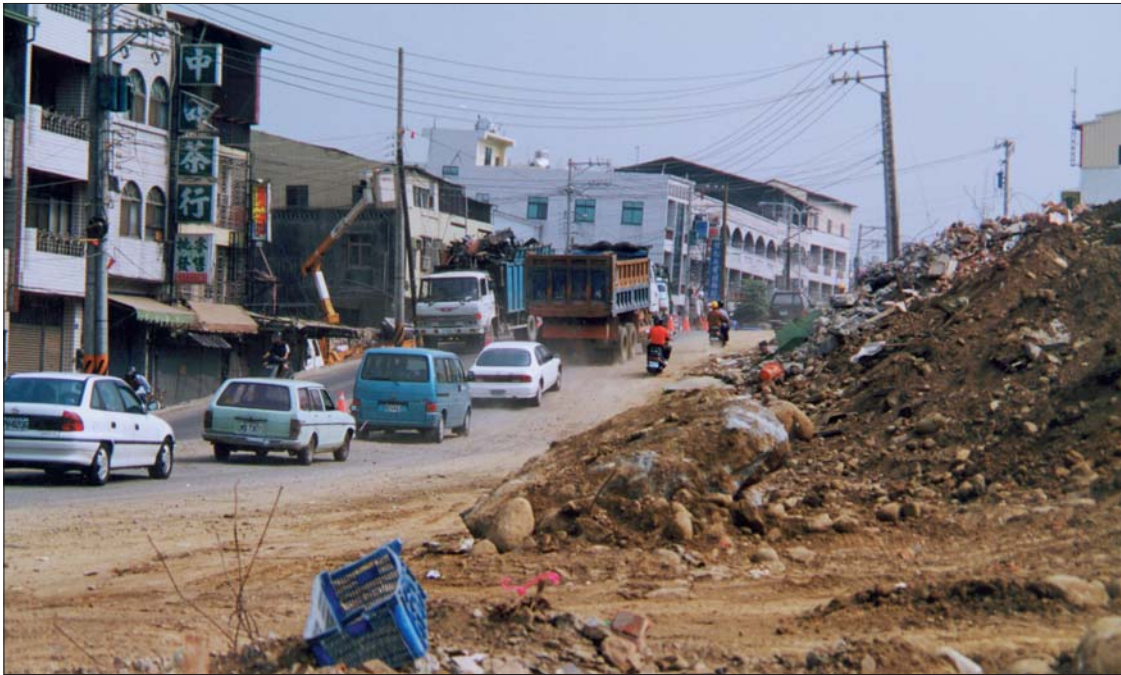
*The Chelungpu Fault rupture and associated warping damaged buildings, infrastructure, and roads in Fengyuan. New maps have been prepared with construction setbacks from fault lines (similar to California's Alquist-Priolo zone requirements).*
