Event Report

# Chi-Chi, Taiwan Earthquake

September 21, 1999 1:47 a.m. M7.6 23.8N 120.8E 7 km depth

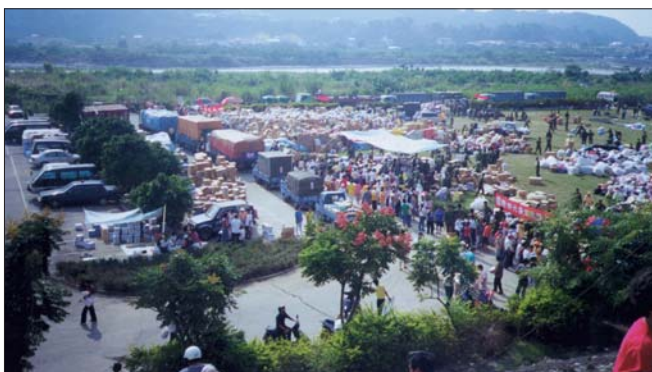
As seen two days after the earthquake, public and private agencies used recreation fields along the river in Dungshu as a staging site for response and relief efforts.

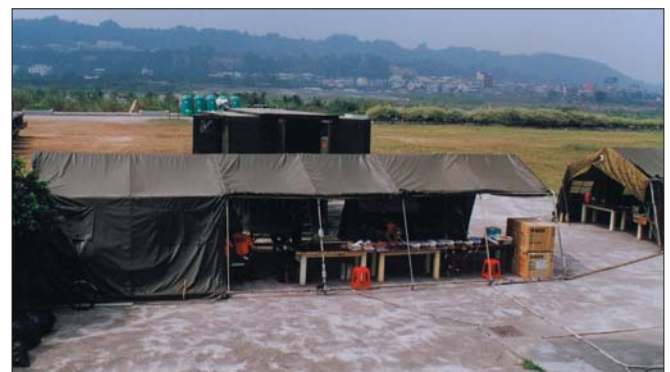
This same site, seen one month after the earthquake, continued to serve as a disaster assistance headquarters for area residents.

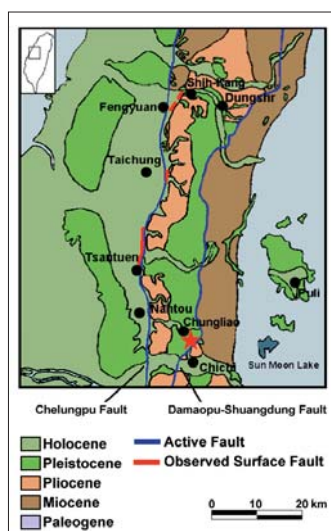
The reconnaissance team investigated approximately half of the 80-kilometer (50-mile) rupture along the Chelungpu Fault, which runs from Shih-kang in the north to Tungtou in the south.

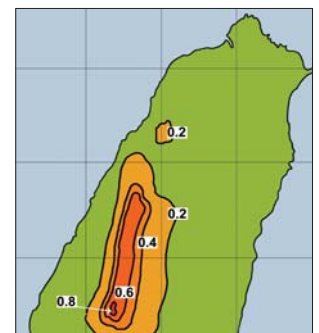
This reproduction of the Central Weather Bureau's preliminary shaking map shows intensities of 0.8 g or greater in the epicentral region.

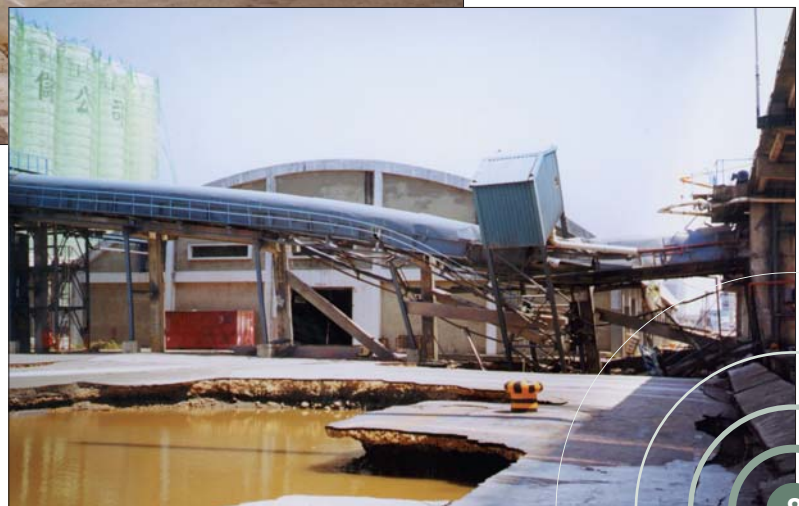
Liquefaction was confined mostly to areas along riverbanks and levees. Only a few sand boils (a key sign of liquefaction) were identified. The most severe liquefaction-induced damage occurred at the port of Taichung. The port is about 20 years old, built in four stages on reclaimed ground. The water table is less than 2 meters (7 feet) below the ground surface, yet ground remediation work at the time of construction appears to have withstood the strong shaking. Only four of the port's 45 berths sustained damage and were out of service due to liquefaction effects.

*As much as four feet of ground settlement was observed along the entire length of a wharf (approximately 1,000 meters, or 3,300 feet) at the port of Taichung.*

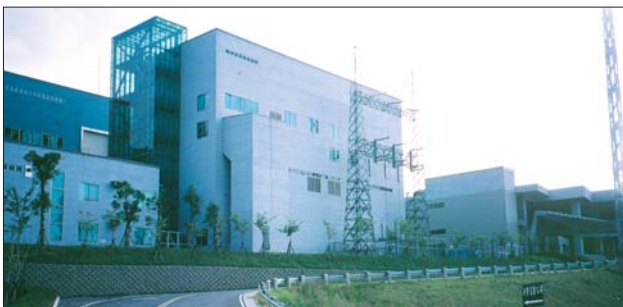
*The newly-opened cogeneration plant is an independent power producer and a valuable auxiliary power source for several semiconductor businesses in the Hsinchu Science Park.*

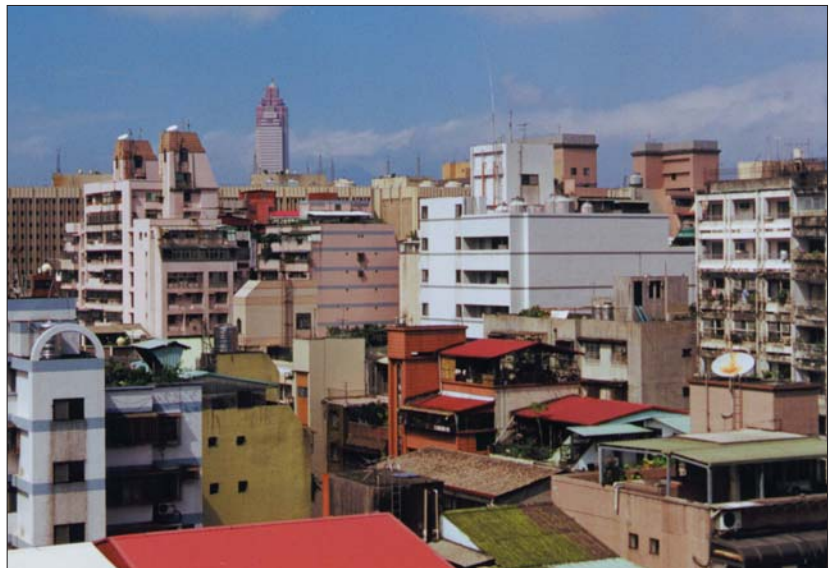
*Most of Taipei's 12 million residents live in dense neighborhoods of predominantly reinforced concrete buildings. The city is also exposed to high seismic risk from active faulting in the region, as well as its close proximity to the highly-active offshore plate boundary.*

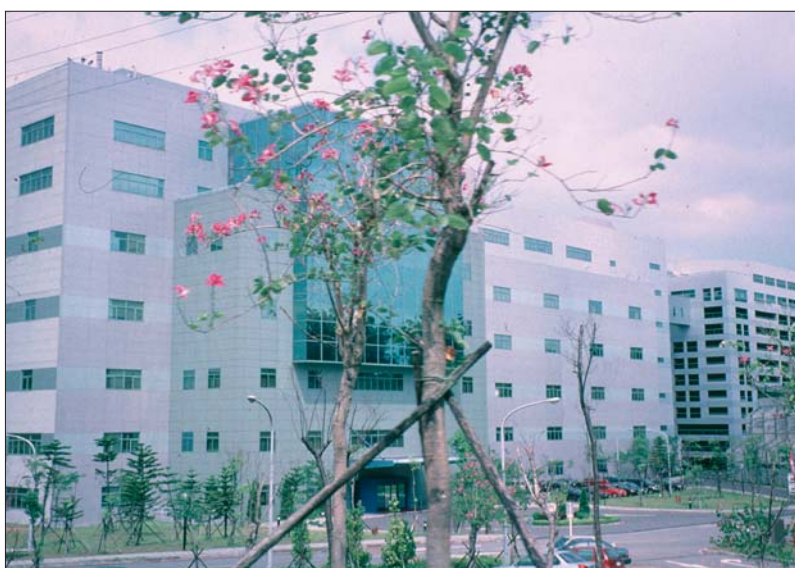
*This major semiconductor manufacturing facility is located in the newest phase 3 of the Hsinchu Science Park.*
